Title: MLM RAIL: DARLEY ABBEY MILLS BRIDGE  
BRIDGE INSPECTION

Historic Structure Recording at

# **DARLEY ABBEY MILLS BRIDGE**

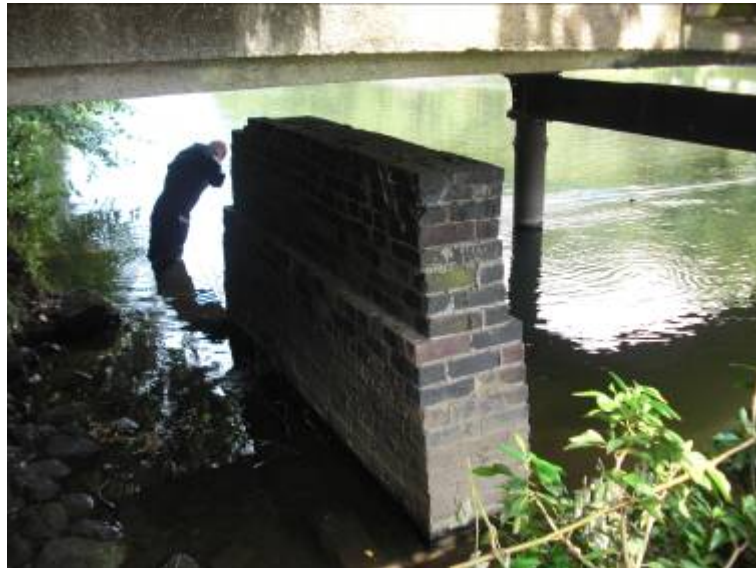
Picture 24 - Redundant brickwork / masonry pier between pier 5 and west abutment.

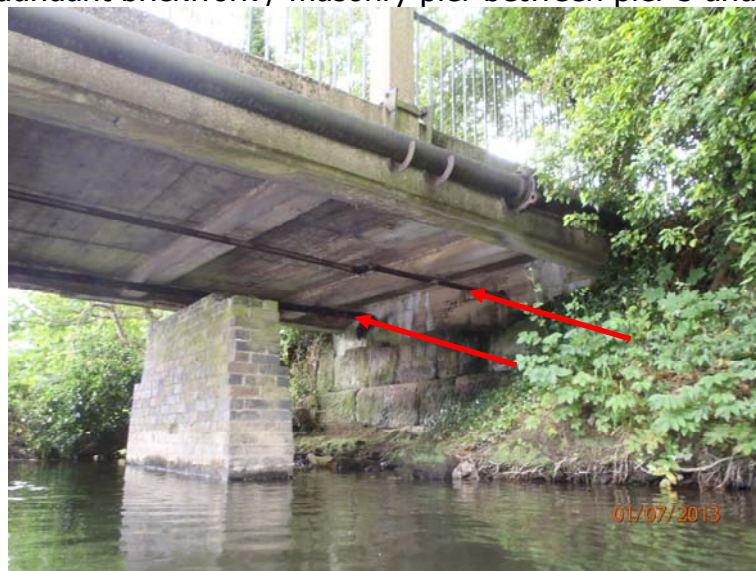
Picture 25 - metal service pipes suspended beneath bridge deck

Minor - Repair / Replace anti-trespass fencing along service pipes suspended from either side of the bridge	40m
High - Remove considerable amount debris from riverbed in vicinity of bridge	5-10m <sup>3</sup>
High - Remove or repair service pipes supported beneath bridge deck, spanning between abutments	80m

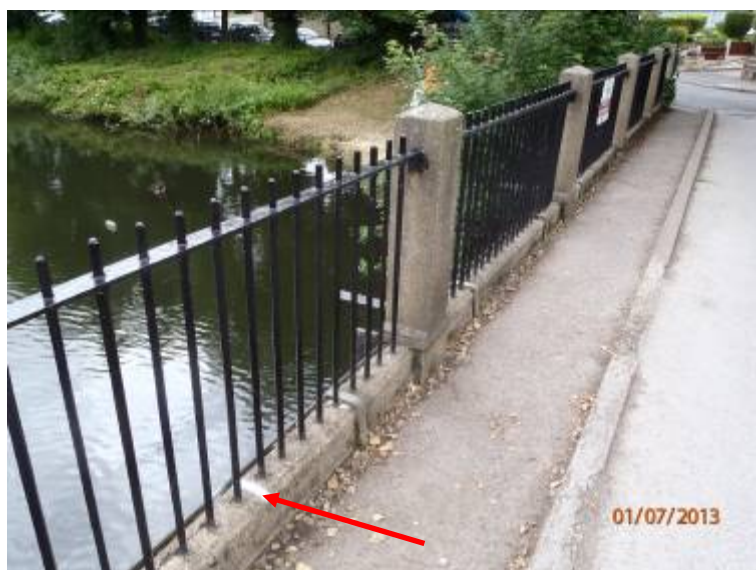
Picture 26 - Location of TBM used for bed profile measurements.
