Title: MLM RAIL: DARLEY ABBEY MILLS BRIDGE  
BRIDGE INSPECTION

Historic Structure Recording at

# **DARLEY ABBEY MILLS BRIDGE**

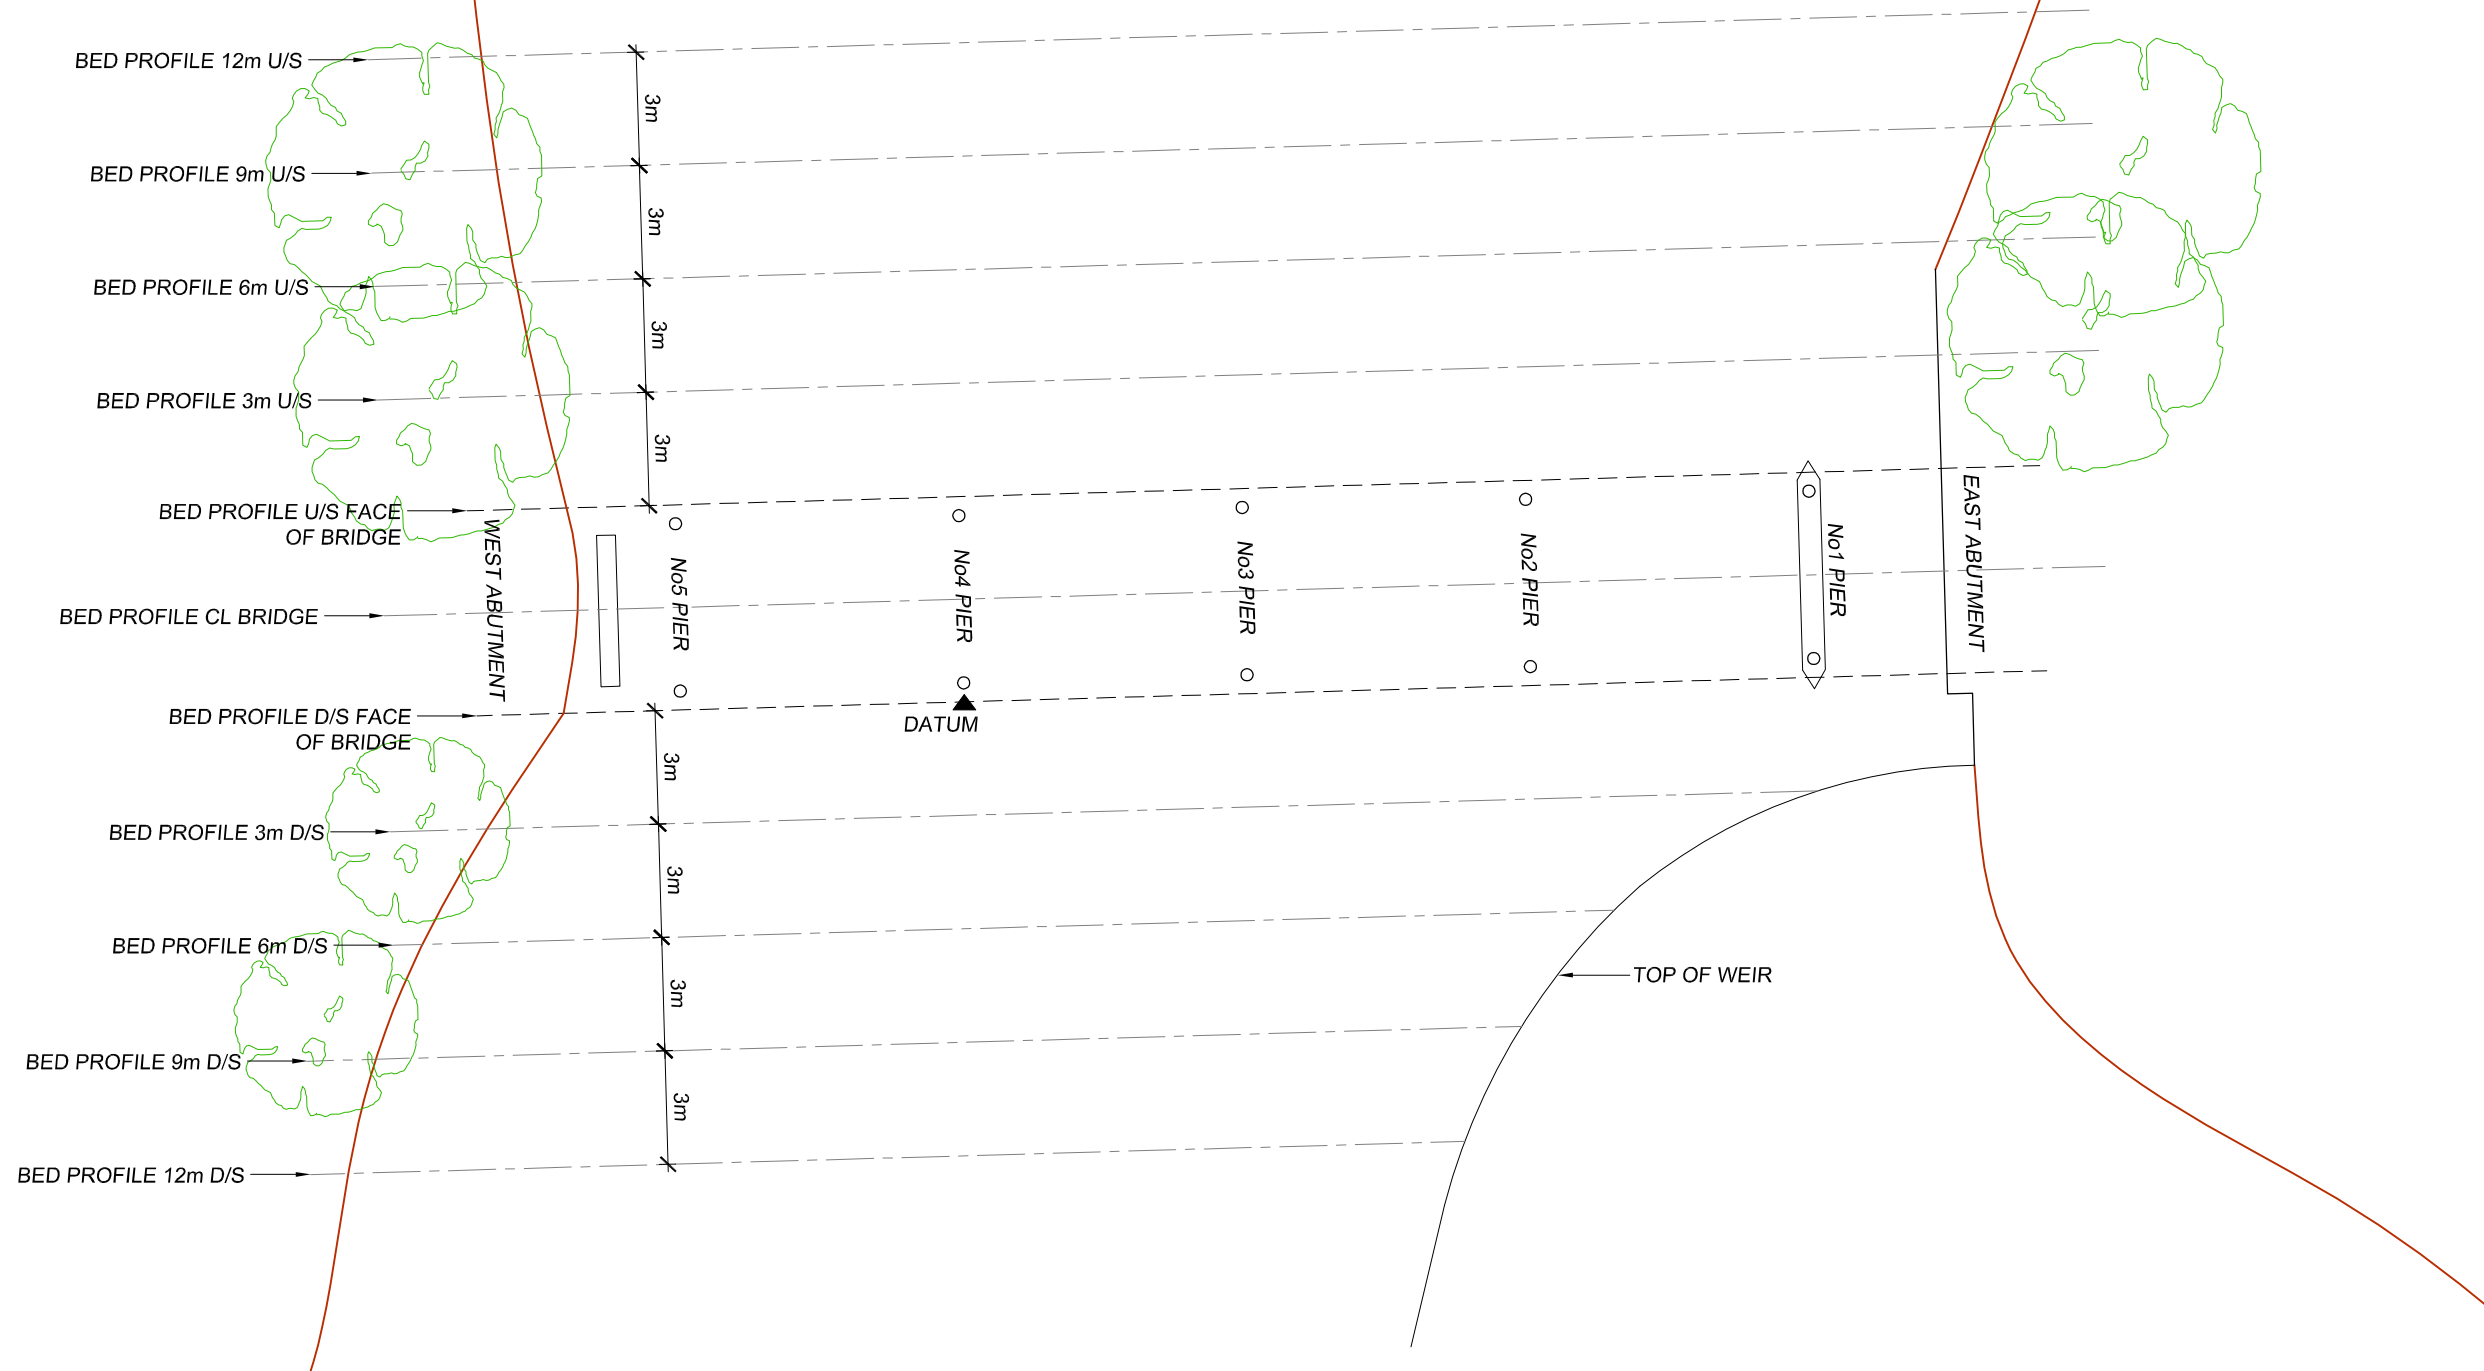
- PLAN -

Brief Overall Condition Assessment			
Poor	Fair	Good	Underwater elements appear to be in fair condition. Superstructure is detailed in a separate report but considered to be in poor condition.
	Yes

Minor - Repair / Replace anti-trespass fencing along service pipes suspended from either side of the bridge	40m
High - Remove considerable amount debris from riverbed in vicinity of bridge	5-10m <sup>3</sup>
High - Remove or repair service pipes supported beneath bridge deck, spanning between abutments	80m
